Notification

PVED-CLS Errata Information.

PVED-CLS Errata Information

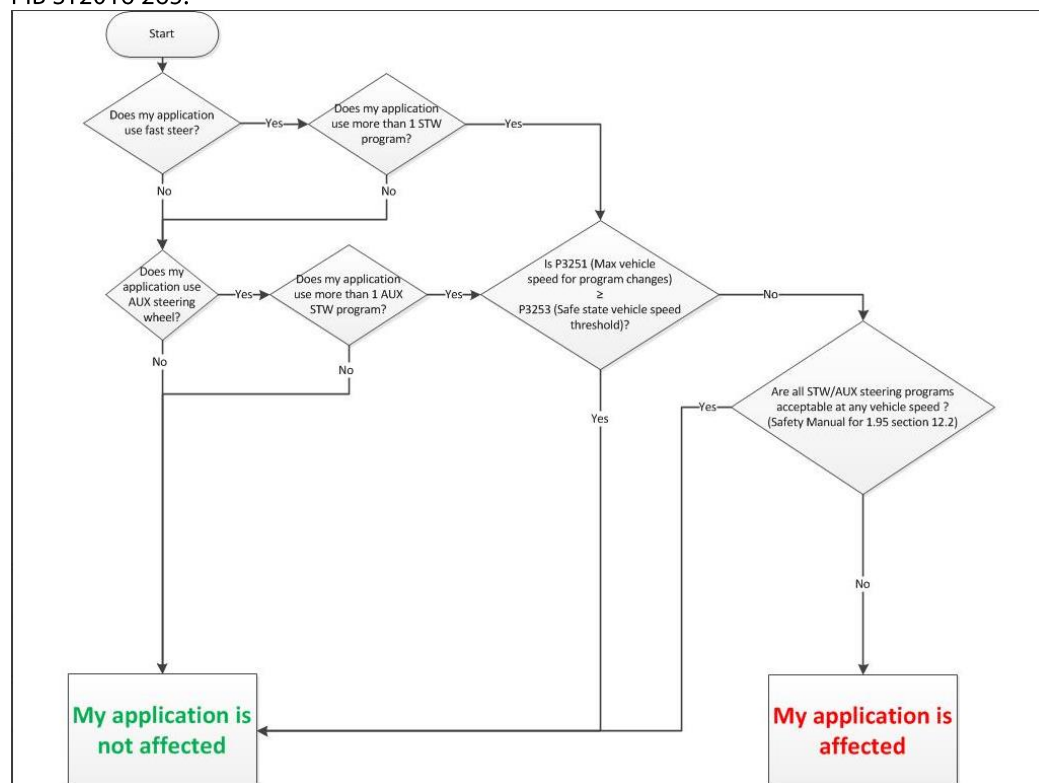
PIB ST2016-265.

SEHS-1278 (S2) : MMI STEERING PROGRAM CHANGE LOCK-OUT SSM_058 does not work as intended

JIRA ID	SEHS-1278
Severity	Medium
Introduction	MMI STEERING PROGRAM CHANGE LOCK-OUT SSM_058 prohibits steering program changes in STW or AUX mode if the vehicle speed is above P3251 (Max vehicle speed for program changes). Additional information can be found in the user manual for 1.95 section 7.1.5 or in the safety manual for 1.95 section 12.2.
Problem	If the MMI steering program change lock-out is utilized and the vehicle speed is above the threshold specified by parameter P3251 (maximum vehicle speed for program changes) and the operator tries to change the steering program (e.g. from STW program 1 to STW program 2), the PVED-CLS appears to remain in STW program 1 signaled in the operation status message. See communication protocol for 1.95, section 7.8. The problem is that the PVED-CLS will switch to the locked-out program and use the lock-to-lock configuration given by steering program 2. This program change is however evident when observing the currently applied lock-to-lock ratio displayed in the steering feedback message. See communication protocol document for 1.95 section 14.

Occurrence	The problem is systematic and not random, it is hence under specific conditions and configurations always present. The defect is isolated to Off-Road operation. Please review the flow chart given in the technical information section if an application is affected or not.
Impact	<p>The specific safety function is designed to avoid unintended (erratic) MMI commands from the Main ECU of the machine.</p> <p>If this controller (sporadically and not as per design) changes the steering wheel program at vehicle speeds above the threshold set by P3251 (typically set at 20 km/h), the operator, depending on attention level and the STW program parameters, will observe a change in the lock-to-lock ratio.</p> <p>Upon a change in the STW program will the lock-to-lock ratio become higher or lower resulting in under- or over-steering. As the operator initiates any direction change of the vehicle through the steering wheel. Overall steering is fully controllable, only the amplification factor may change noticeable.</p> <p>If customers and system integrators have integrated the PVED-CLS as specified and recommended in the safety manual, will this defect have no impact at all.</p> <p>The flow chart in the technical information section can assist in determining if an application is potentially affected or not.</p>

Work around	<p>Review Safety manual for 1.95 section 12.2 for recommendations on safe steering program setup.</p> <p>To determine the best possible workaround requires analysis of the individual application - contact Danfoss PAE for advice.</p>
Seen on SW version	1.92, 1.93, 1.95 & 1.96
Solved in SW version	1.97
