## Case Study

# Vickers® by Danfoss

## Collaboration is key during UK harbour cylinder refurbishment project

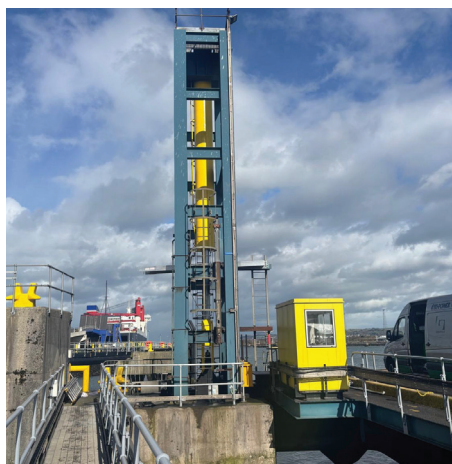
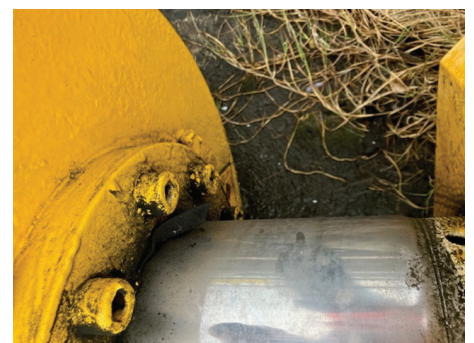
The primary challenge was the severe corrosion of the threaded end caps on the linkspan cylinder. This corrosion made disassembly and maintenance extremely difficult, threatening the cylinder's operational lifespan and the functionality of the linkspan. The existing design made it almost impossible to remove the end caps without causing further damage.

Danfoss engineers devised a solution involving machining down the corroded end caps and re-engineering the design to incorporate bolted end caps. The result was a refurbished 9m long cylinder with a new design that offered a more secure and accessible method for future disassembly and maintenance. The collaboration with Flowtech was crucial, leveraging their local expertise and facilitating seamless communication with the client.
