## Case story | MTCV Thermostatic Circulation Valves

# Why **hot water is key** for happy hotel guests

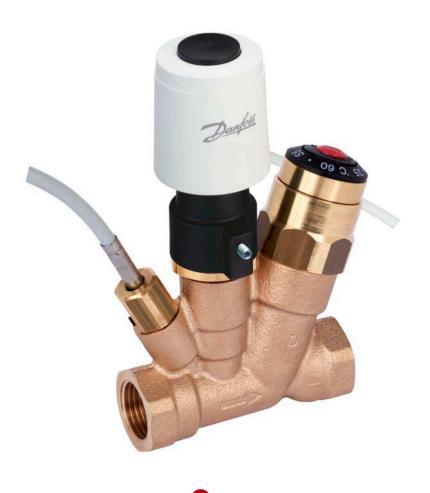
MTCV Multifunctional Thermostatic Circulation Valve and CCR2+ electronic controller **"Our guests should** not have to wait a long time for reliable hot water and with the MTCV we have reduced waiting times to less than one minute. It has transformed our system and our guests are very happy, which is great for our business."

MTCV creates a thermal balanced system by enabling constant temperatures in every circulation pipe, optimizing performance, and ensuring hot water is available when and where it is needed.

Throughout the hotel, a total of 64 MTCV-C valves were installed on the circulation pipes of all DHW branches.

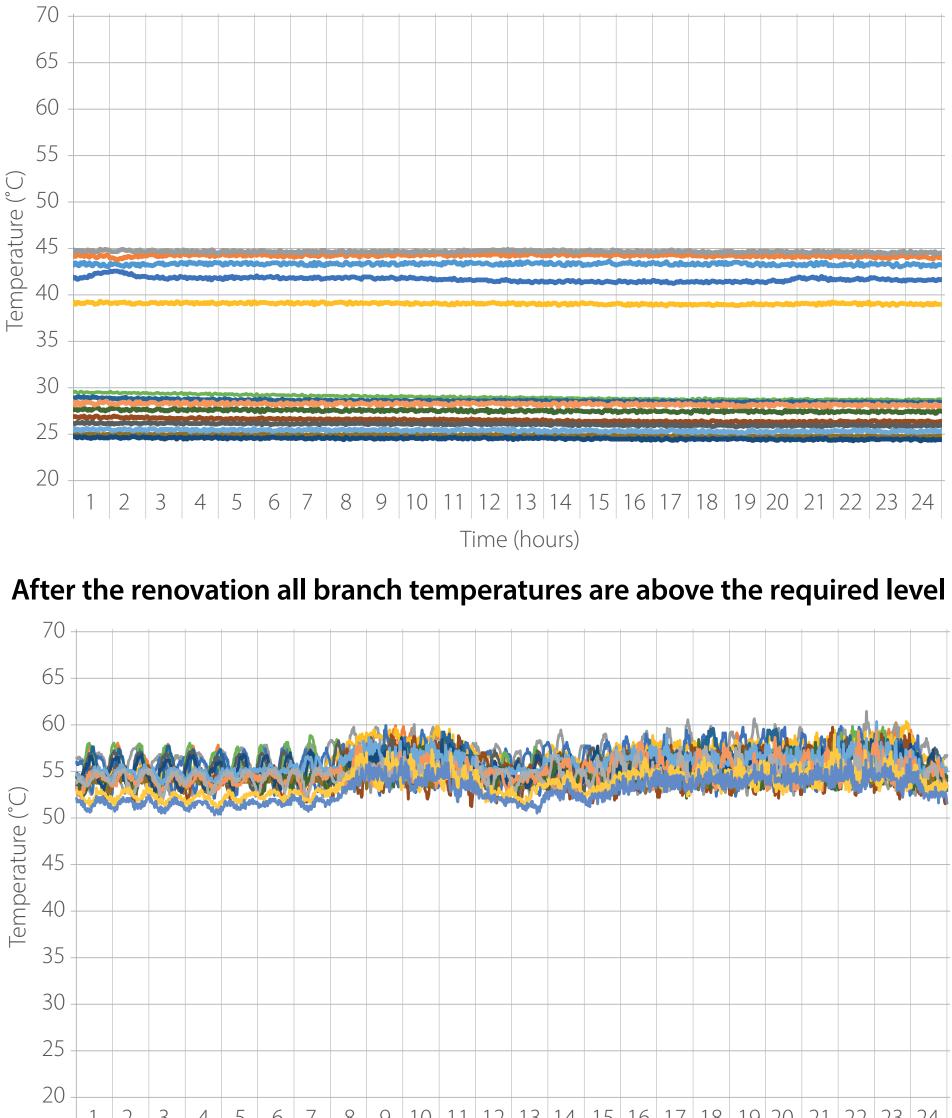
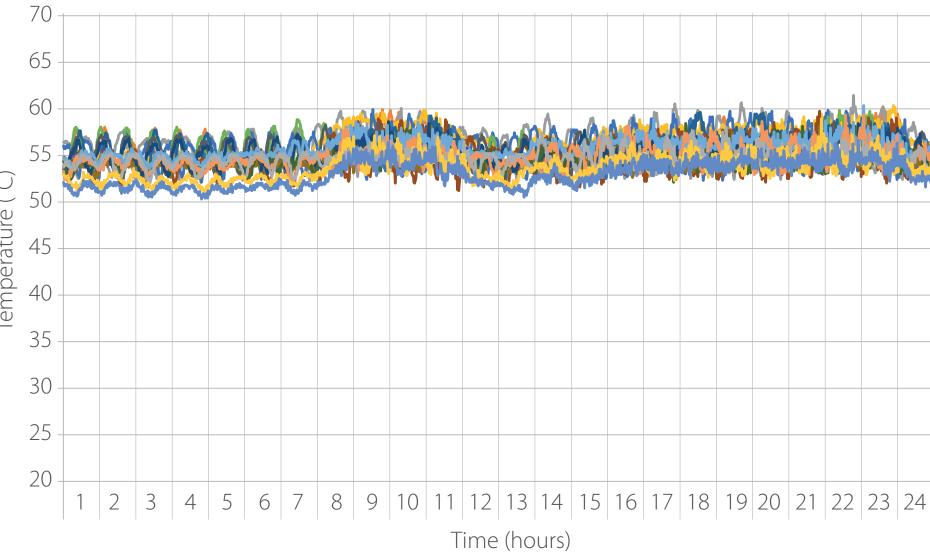
Temperature measured by a certain sensor:

#### Before the renovation, insufficient flow meant branch temperatures were too low

In the first run, the system was operated like normal. The temperature measurement confirmed the issue with long waiting times, as the furthest located branches had low water temperatures. The oil consumption measured over a 24-hour operation was 103.5 liters.

In the second test, the system was heated to its maximum in order to achieve higher temperatures at the furthest branches. The waiting time was around 20 minutes for the last tapping point to provide the required 50°C. The oil consumption rose to 135 liters over 24 hours.

In the third test, the system was set to use the MTCV thermal balancing valves. The waiting times were reduced to below one minute. The furthest tapping point achieved the required 50°C within that shortened waiting time. The oil consumption was 111.5 liters over 24 hours.

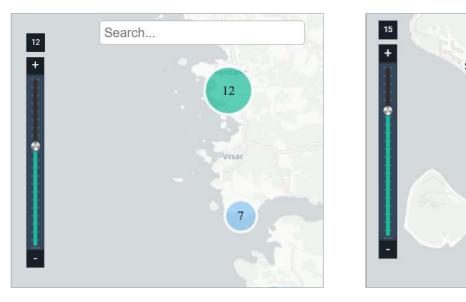
### The cloud-based, centralized DHW control system shows the status of all site locations

Maistra looked at the technical possibilities the CCR2+ controller offers and decided that the optional connection and integration of all the CCR2+ controllers in one cloud-based control system would optimize services even further. Centralizing the data made it easier to access. All temperatures from all the hotels' DHW systems are now visible at the touch of a button.

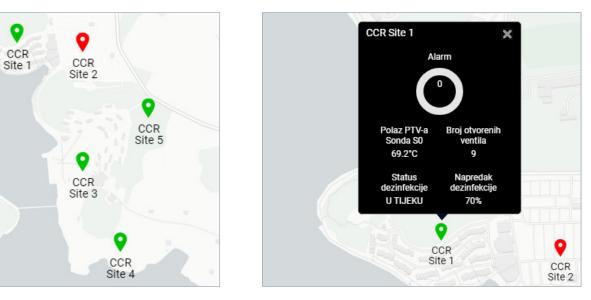
### The Agenor app shows detailed information on Maistra technicians' mobile devices

Maistra took this a step further. To serve their different technicians, Maistra worked with a system integrator, Agenor automation, to also include an app. Technicians can now carry valuable information with them. For example, if an alarm is sent during a disinfection cycle, they can check the system from their mobile device.
